Lake Gaston Weed Control Council Meeting NCSU Update March 10th, 2022

2021 Water Quality Report

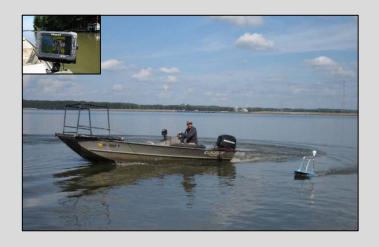
- Entire Shoreline Sampled
- Dual Track Sonar
- September and October
- Data uploaded to BioBase
 - Calculate BioVolume

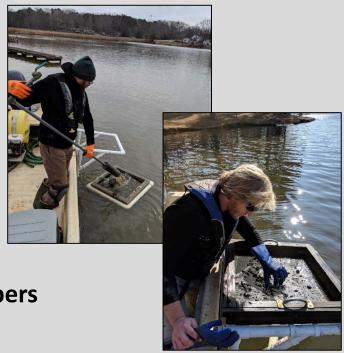
- Sampled December 2021
- 18 Total Creeks
 - Based on historical hydrilla presence
 - 3 6 sample sites per creek
- Samples are Collected Using Core Sampler
- Samples Rinsed Over Screen to Exposed Tubers
- Total of 30 50 core samples per sample site
- Tuber Densities Calculated per Site
 - Sites are averaged per creek

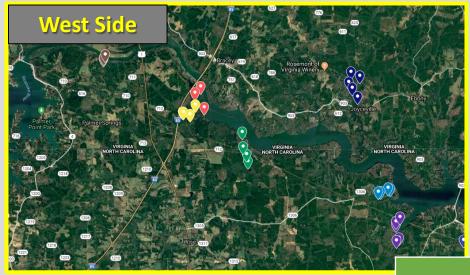
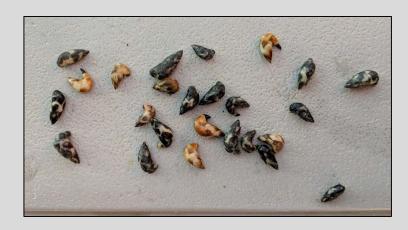
- Slightly higher detection rates than East side sites
- Monitoring still needed
- Successful Management!

2012	2020	2021	Last Detection
Hubquarter	292.73	1.64	0	1 yr
Lyons Creek	293.96	0	0	2 yrs
Poplar Creek	89.63	8.22	0	1 yr
Hawtree	38.03	6.58	4.93	0 yrs
Smith Creek	8.22	0	0	6 yrs
Flats	119.23	0	0	3 yrs
Cotton Creek	217.90	42.48	0*	1 yr

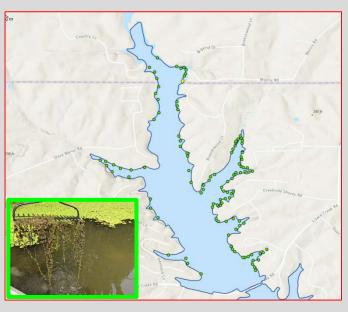
- Tuber Bank Density
- Chara Refuge

2014	2015	2016	2017	2018	2019	2020	2021
Lizard Creek	58.93	30.15	3.29	0.00	49.34	18.91	0.00	24.39

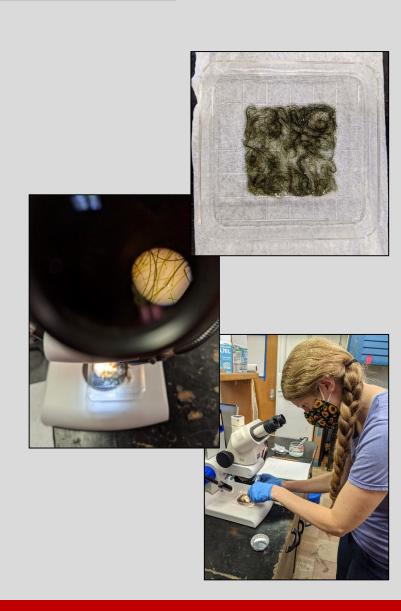
- Field samples were collected in December from:
 - Hawtree (experimental / multi-year)
 - Site 18 & 19 (1st Year)
 - Controls
- Samples were collected from two sites within each treatment area
- Two samples from each site were analyzed
- Viability was quantified by two separate readers

Determine what percent of the lyngbya in the viewing area was alive

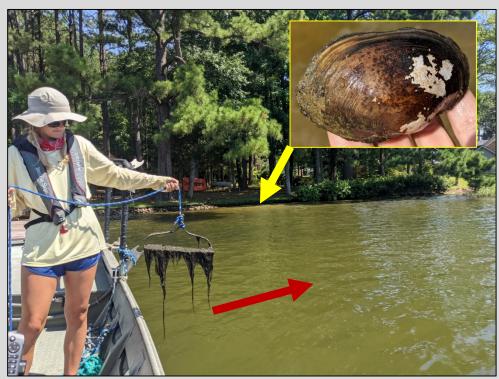
- Treatment Modification
 - Mussel beds were located in sandy, shallow habitat
 - New application method able to inject copper in much shallower habitat instead of spraying
 - Lyngbya mats were located in deeper water

Algaecide was not applied in water < 5 feet the remainder of the season to avoid preferred mussel habitat.

No additional mortality was reported
