# **Lake Gaston 2013 Submerged Vegetation Mapping Summary Report**

*Hydroacoustic Sampling with  
Species Point Sampling*

Submitted to the Lake Gaston Weed Control Council  
Feb 18, 2014

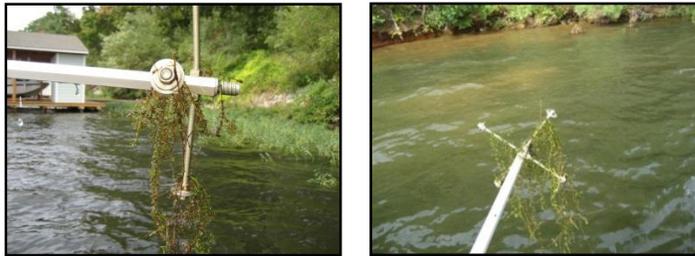
A total of 889 permanent sites were sampled for aquatic plants in 2013, 861 of which were in the main lake. Twenty-eight additional sites were sampled in Cotton Creek and the western river channel. Plant sample data were collected by using a vegetation sampling tool (Figure 7). The tool consisted of two 16" X 5/8" bolts inserted perpendicular to each other so they are centered approximately 1" from the threaded end of a 25' extension pole. At each sample location, the threaded end of the vegetation sample tool was placed into the water until it touched bottom. The tool was then twisted several times and pulled from the water. ReMetrix has adopted this vegetation sample tool, opposed to a thatch rake, because it does a better job collecting short rooted plants, the user can ensure the tool is making sufficient contact with the bottom, and the samples taken from it are more representative of the vegetation at the exact coordinate being surveyed.

*Figure 7. Sampling tool photos.*

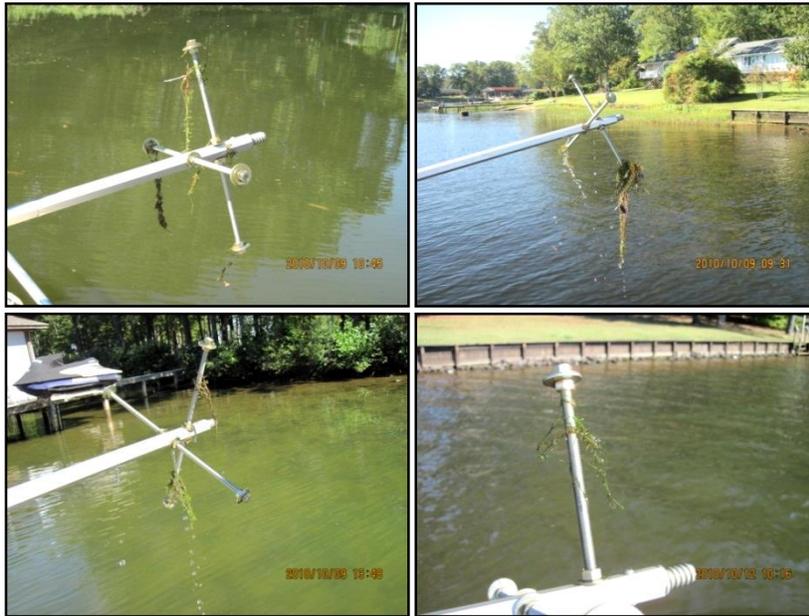
*Figure 11. A representative example of pole samples where cover rating equals ‘5.’*

As the photos indicate, sites ranked as ‘5’ frequently had scant plant cover, sometimes as little as one or two stems of plant. So while plant was technically found at these sites, the cover is often sparse enough to be considered negligible. In the context of evaluating the contribution of such sites to the omission and commission error statistics, one is forced to weigh the statistical definition of a classification discrepancy against a practical definition. To gain a better understanding of how these samples affect the omission and commission errors, an analysis was generated to further investigate these points (Table 3).

The greatest source of discrepancy in Table 2 is where the pole sample indicated ‘plant’ but the model indicated ‘no plant,’ resulting in a 17.7% omission error and a 15.4% commission error. ReMetrix investigated the 89 locations that represented this discrepancy. Of the 89 locations, 78 (87%) were either Lyngbya, dead plant, or had a cover rating equal to ‘5’ from the pole sample (less than 20% plant cover). Figure 11 below shows a representative sample of Lake Gaston pole samples with a cover equal to ‘5.’

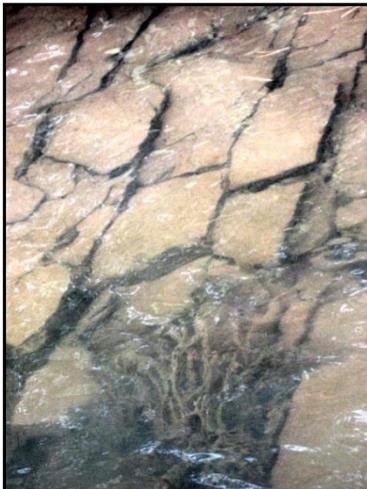
Most of the remaining error in Tables 2 and 3 can be explained by the patchiness or randomness of aquatic vegetation in some areas (see Figure 12 as an example), and the characteristics of the varied shoreline. A majority of the 11 areas where the model indicated there was plant but the pole sample indicated “no plant” also occurred in areas of very low-density vegetation, where the probability of the pole contacting vegetation was low. No adjustments were made to the models for these areas since the hydroacoustic samples indicating some plant presence vastly outnumber the pole samples. A review of the hydroacoustic data for many of these areas confirmed that these zones typically have low-density plant populations where a limited number of pole samples may have easily missed patchy plant beds.

*Figure 12. Example of patchy hydrilla surrounded by bare substrate in Lake Gaston.*
