A Historical Overview of the Lake Gaston Habitat Enhancement Project

July 2019

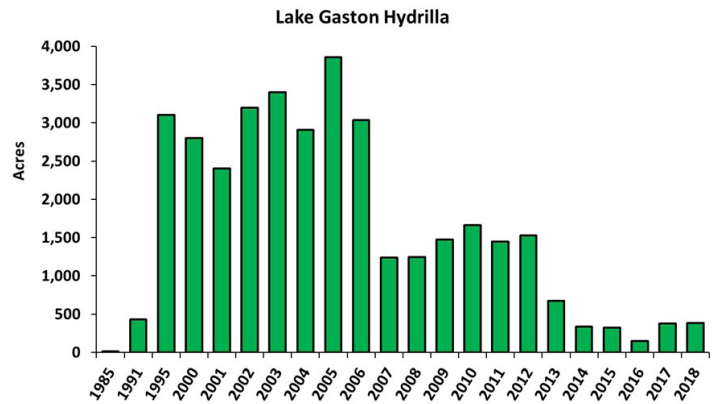
FIGURE 2.—Acres of hydrilla from 1985–2018 at Lake Gaston.

A winter drawdown was conducted in 1987–1988 and was successful at controlling Brazilian elodea, yet had stimulatory effects on hydrilla tuber sprouting and likely contributed to a worsening of the hydrilla problem. Hydrilla infestations increased to 429 acres by 1991, and to over 3,000 acres from 1995 through 2006. Triploid Grass Carp were first stocked into Lake Gaston in 1995 and were stocked at relatively low levels (approximately 8 to 15 fish per acre

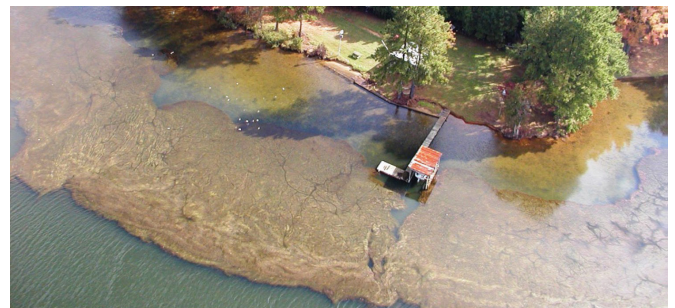
FIGURE 3.—Hydrilla engulfing a boat ramp at Lake Gaston.

Aquatic vegetation is an important component of productive fish and waterfowl habitats. Aquatic macrophytes also serve to anchor bottom sediments, stabilize underwater slopes, and remove suspended particles and nutrients from overlying waters. Invasive-exotic aquatic vegetation can displace native vegetation and has a tendency to spread quickly. Specifically, hydrilla (a federal and state noxious weed) skyrocketed in Lake Gaston since first appearing there in the 1980s (Figure 2). Surveys conducted by North Carolina State University in 1985 discovered 200 acres of Brazilian elodea and 12 acres of hydrilla. Hydrilla infestations lead to several undesirable events, including the loss of municipal and recreational use of waters and habitat alterations. Advanced infestations decrease the available volume of water, inhibit recreational activities, and have the potential to foul water withdrawal intakes, along with outcompeting native vegetation. Docks and boat slips can become unusable during the summer and fall months when surrounded with dense hydrilla growth (Figure 3).

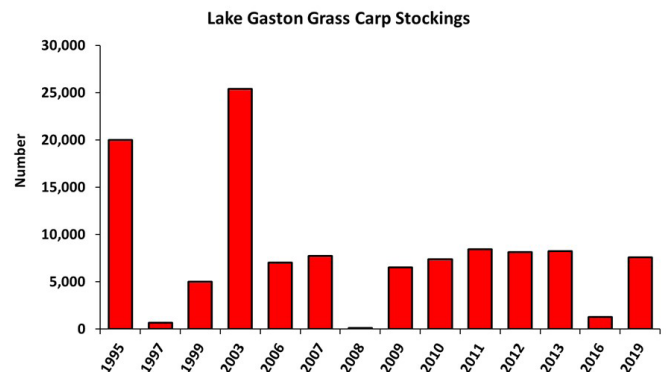
FIGURE 4.—Grass Carp stocked into Lake Gaston from 1995–2019. Note: stockings were not conducted annually.

of hydrilla) until 2011, when 18.5 fish per acre were stocked (Figure 4). Grass Carp stocking recommendations are based on a cohort model developed by the Commission and adjusted to the stocking rate per acre of hydrilla along with annual fish mortality rates. Stockings have remained at 18.5 fish/acre of hydrilla since 2011 and are based on fall surveys conducted by NC State University and numerous volunteers. This survey is critical to monitor results and plan for treatment options the following year. The most recent survey in the fall of 2018 showed hydrilla at less than 400 acres. Complete eradication of aquatic vegetation can increase shoreline erosion and have serious negative impacts on f have been established as founder colonies at numerous sites throughout the lake. Submersed plants needing protection from herbivores, such as eelgrass and pondweed, were planted within fenced exclosures at many of the sites (Figure 5).

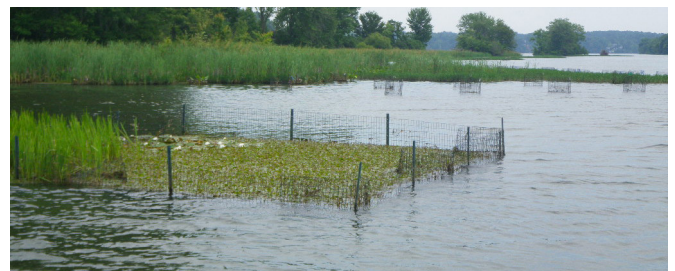
FIGURE 5.—Example of a fenced enclosure to protect native vegetation at Lake Gaston.
