2024 Lake Gaston Vegetation Survey Report

March 2025

North Carolina State University

Aquatic Plant Management Program

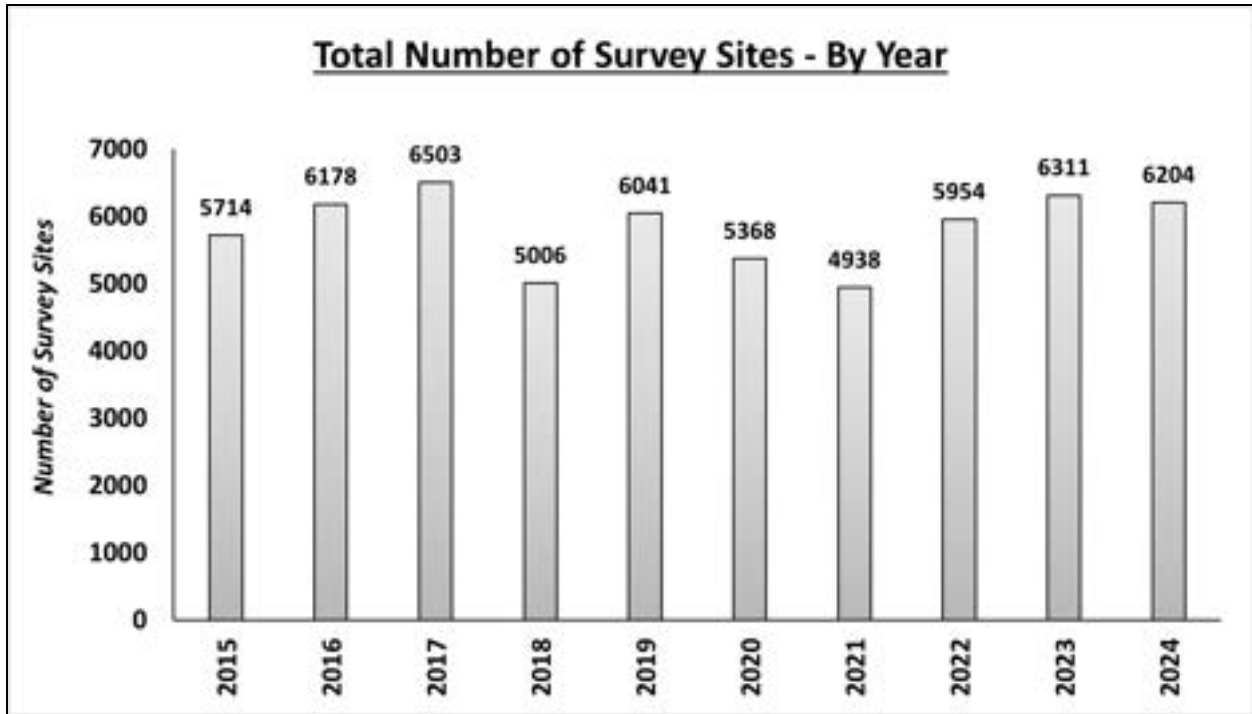
Figure 1. Bar graph representing total sites surveyed during yearly vegetation surveys conducted on Lake Gaston, NC/VA between 2015 and 2024.

The 2024 point intercept survey was conducted between August 16th and October 29th. During this timeframe, 60 individual teams comprised of 106 volunteers surveyed a total of 5,637 sites. These teams put in a total effort (including both preparation and active surveying time) of 622 hours for the 2024 survey and accounted for 529 hours of the active surveying time. NCSU staff surveyed a total of 567 sites and accounted for 30 hours of active surveying time. In total, 6,204 sites were surveyed by both volunteers and NCSU in a time span of 560 hours. This level of sampling effort is comparable to previous survey years (Figure 1).

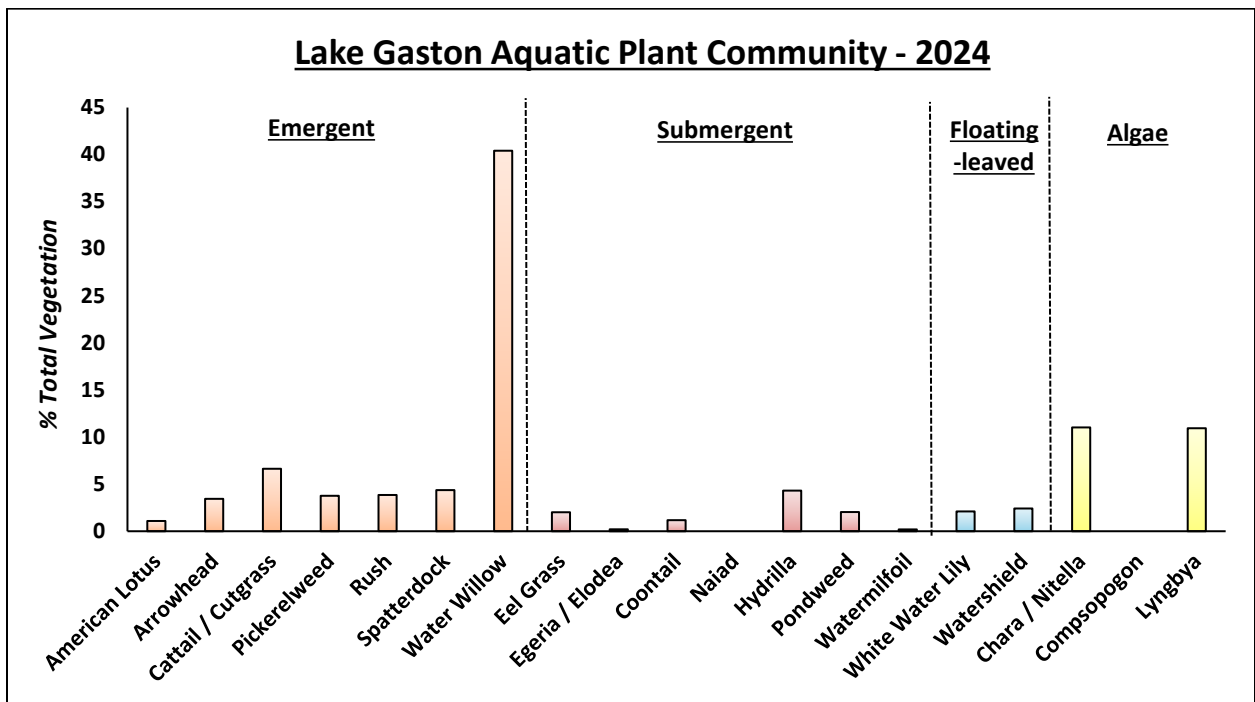
Figure 2. Bar graph representing the overall aquatic plant community of Lake Gaston, NC/VA in 2024. Overall, the community is represented by emergent (64%), submersed (10%), floating-leaved (5%), and algae (22%) species.

Overall, 81% of the sites surveyed contained aquatic vegetation (Table 1). The aquatic plant community was primarily comprised of emergent species (64%), followed by algal species (22%), submersed species (10%), and floating-leaved species (5%). (Table 1; Figure 2). Due to the high stocking rate (18.5 fish / standing acre) of Grass Carp within Lake Gaston as part of an integrated management protocol for hydrilla, the low percentage of submersed and floating-leaved species was expected. Grass Carp will indiscriminately feed on other aquatic plant species in addition to hydrilla, although emergent and algal species are not generally a preferred food source. Within the aquatic plant community, water willow was the most prevalent species found (40%) (Table 1; Figure 2) and has consistently remained the most

abundant plant found within the system since 2018. The second most abundant species were represented two alga's, lymngbya and chara, both of which made up 11% of the total vegetation (Table 1; Figure 2). Water willow and lymngbya are also well distributed throughout Lake Gaston; however, chara is more closely associated with those areas that are not heavily infested with lymngbya, such as Pea Hill and Lizard Creeks (Figures 3-5). Both water willow and chara are considered native beneficial species, while lymngbya is considered a nuisance alga that can have negative impacts to aquatic ecosystems.

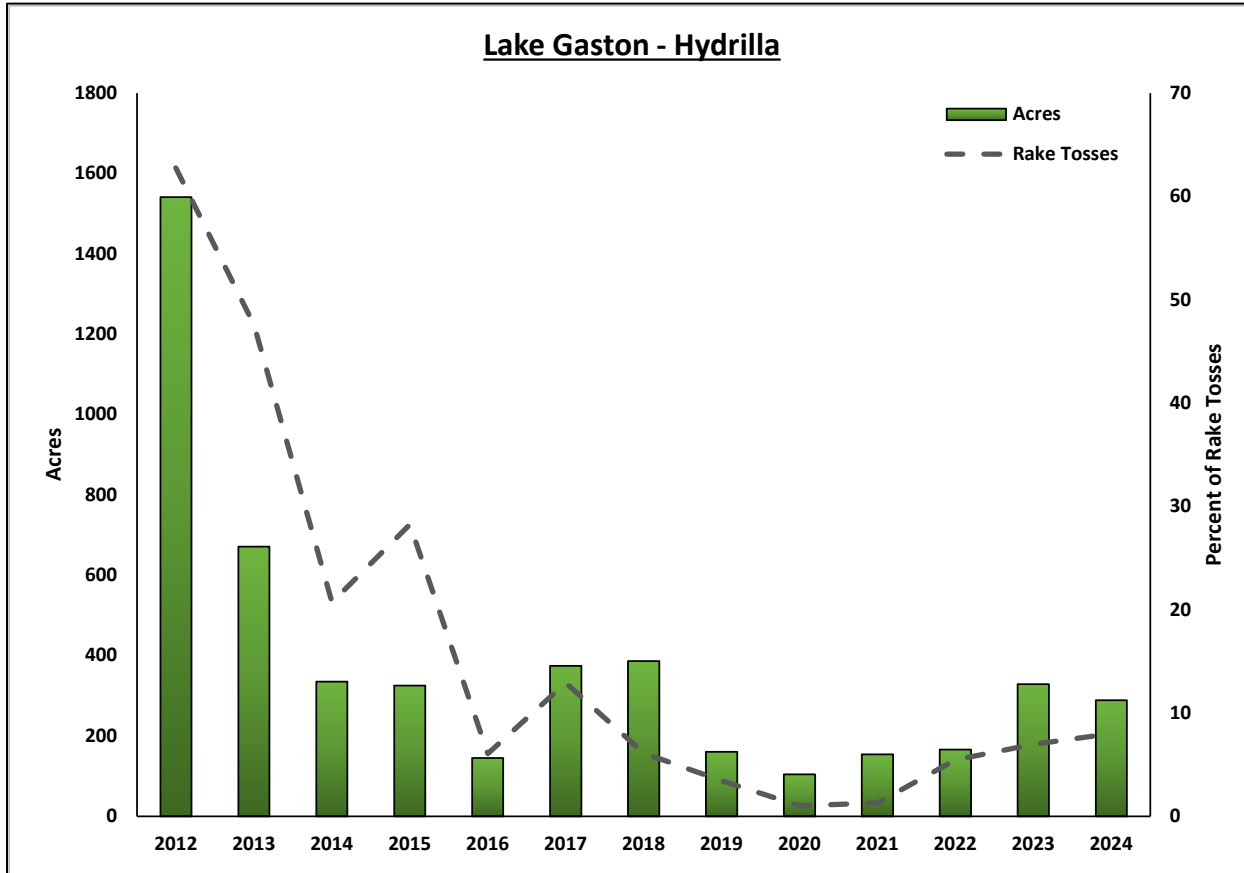
Hydrilla was distributed throughout Lake Gaston in 2024 (Figure 6), however overall acreage has remained at low levels since 2014 (Figure 7). NCSU has been actively involved in the management of the aquatic plant community since 2012, and during that time the standing acreage of hydrilla has decreased from 1,541 acres reported in 2012 to 289 acres in 2024 (Figure 7). Percent occurrence of hydrilla within sites surveyed has also followed a negative trend, with hydrilla being reported at 64% of survey sites in 2012 and only 6% in 2024 (Figure 7). Results from the tuber bank survey conducted in winter of 2024 also indicate a drastic decrease from initial densities reported in 2012 (Table 2). The tuber bank located within the eastern portion of the lake (east of Eaton Ferry's Bridge) remains near undetectable levels. Lizard and Jimmies Creek are the only creeks in which a persistent tuber bank has been detected over the last three sampling years, but both sites displayed decreases from the reported 2023 density levels. The western portion of the lake (west of Eaton Ferry's Bridge) also remains near undetectable tuber bank levels. Hawtree and Cotton Creek were the only two areas in which tubers were detected, and both creeks have consistently reported a tuber bank presence over the last three years. The highest density of tubers detected during the 2024 survey season was reported in Hawtree Creek (24.67 tuber/m²).

Figure 7. Estimated standing acreage (bars) and percent occurrence in the vegetation survey (line) of hydrilla in Lake Gaston, NC/VA between 2012 and 2024.

- Hydrilla remains at low acreage levels throughout the system and current management strategies seem to be effective at managing and maintaining this invasive species. Overall acreage has decreased from 2023 to 2024 and tuber bank detections remained relatively stable suggesting hydrilla expansion has not occurred. Continued management of this species is recommended due to the rapid growth potential presented from overwintering vegetative structures (tubers and turions).

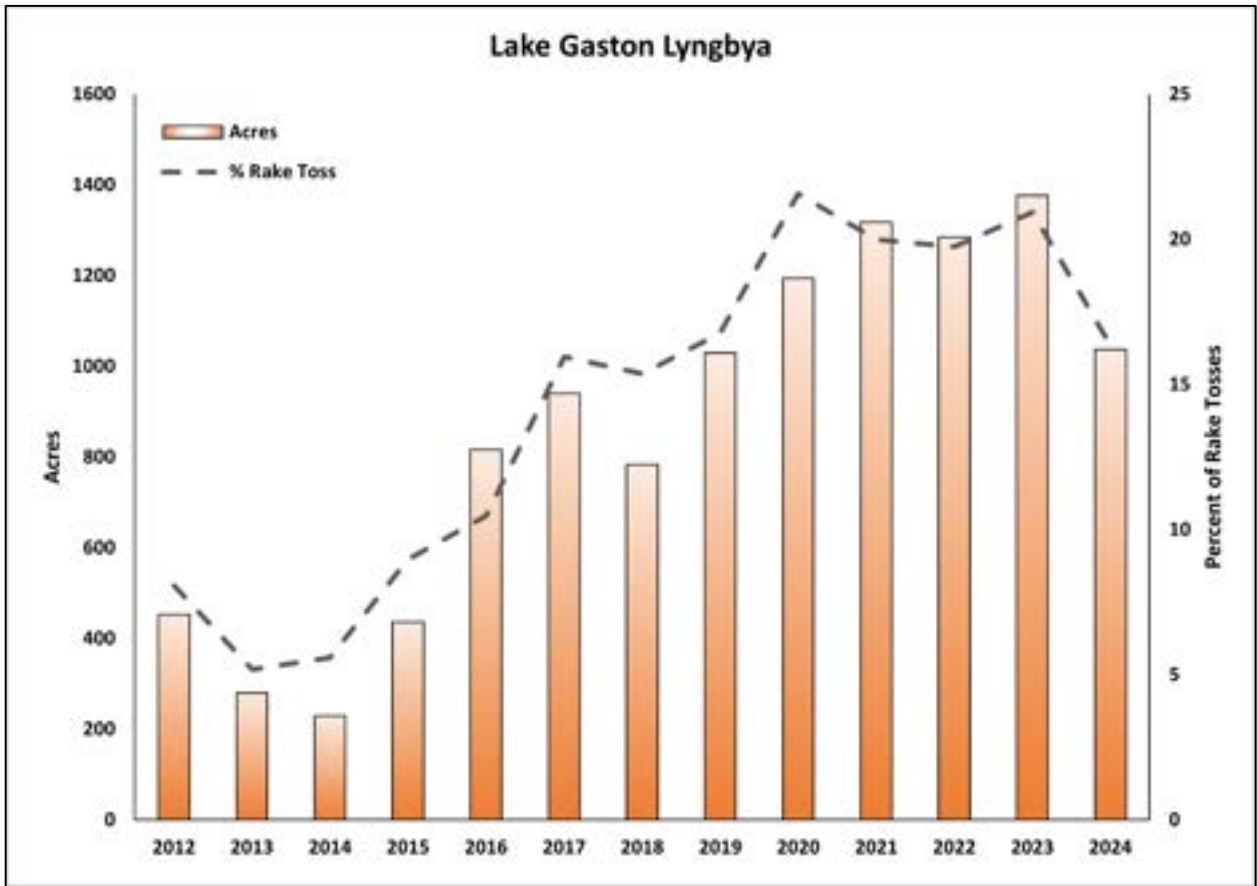
In 2024, lymngbya represented 11% of the total aquatic plant community, was present at 16% of sites surveyed, and was estimated to cover 1,037 acres along the shoreline of Lake Gaston (Table 1; Figure 8). Since 2020, lymngbya has been the second most prevalent species reported in Lake Gaston and has steadily increased in total acreage from 2012 to 2021 (Figure 8). However, in 2021 management efforts directed at lymngbya intensified and 300 acres of lymngbya were targeted for direct management utilizing algaecide treatment protocols. The treatment program increased the targeted amount of acres to 375 for the 2022 and 2023 seasons, and 500 acres for 2024. This increase in directed management coincides with reported lymngbya acres that were maintained at approximately 1,300 between 2021 and 2023, and then decreased to 1,037 acres in 2024. However, it should also be noted that a decrease in overall growth potential was displayed system wide for lymngbya in 2024. Surface mat formations were found at low levels in areas that have been historically inundated, and in certain areas, benthic mats were not as robust as in previous years. Therefore, it is difficult to determine the driving factor for the decreased lymngbya acreage in 2024.. Temporal trends

Figure 8. Estimated standing acreage (bars) and percent occurrence in the vegetation survey (line) of lyngbya in Lake Gaston, NC/VA between 2012 and 2024.

- The current lyngbya management program within Lake Gaston is producing positive results. Success of this treatment program could potentially be reflected in the stability of reported lyngbya acreage from 2021 to 2023 and the decrease in acreage reported in 2024. However, the distribution of lyngbya is widespread throughout Lake Gaston, with many areas still displaying moderate to dense mat densities. Continued management of this algal species is recommended.
